ASSESSING GROUND-WATER RECHARGE THROUGH THE PAJARITO FAULT ZONE, UPPER PAJARITO CANYON, LOS ALAMOS, NEW MEXICO

DALE, Michael¹, GOFF, Fraser², GRANZOW, Kim¹, LONGMIRE, Patrick³, and COUNCE, Dale³
¹ NMED DOE Oversight Bureau, 134 State Road 4, Suite A, White Rock, NM 87544, mdale@lanl.gov
² Earth and Planetary Sciences Dept., University of New Mexico, Albuquerque, NM 87131
³ Los Alamos National Laboratory, EES Division, MS D469, Los Alamos, NM 87545

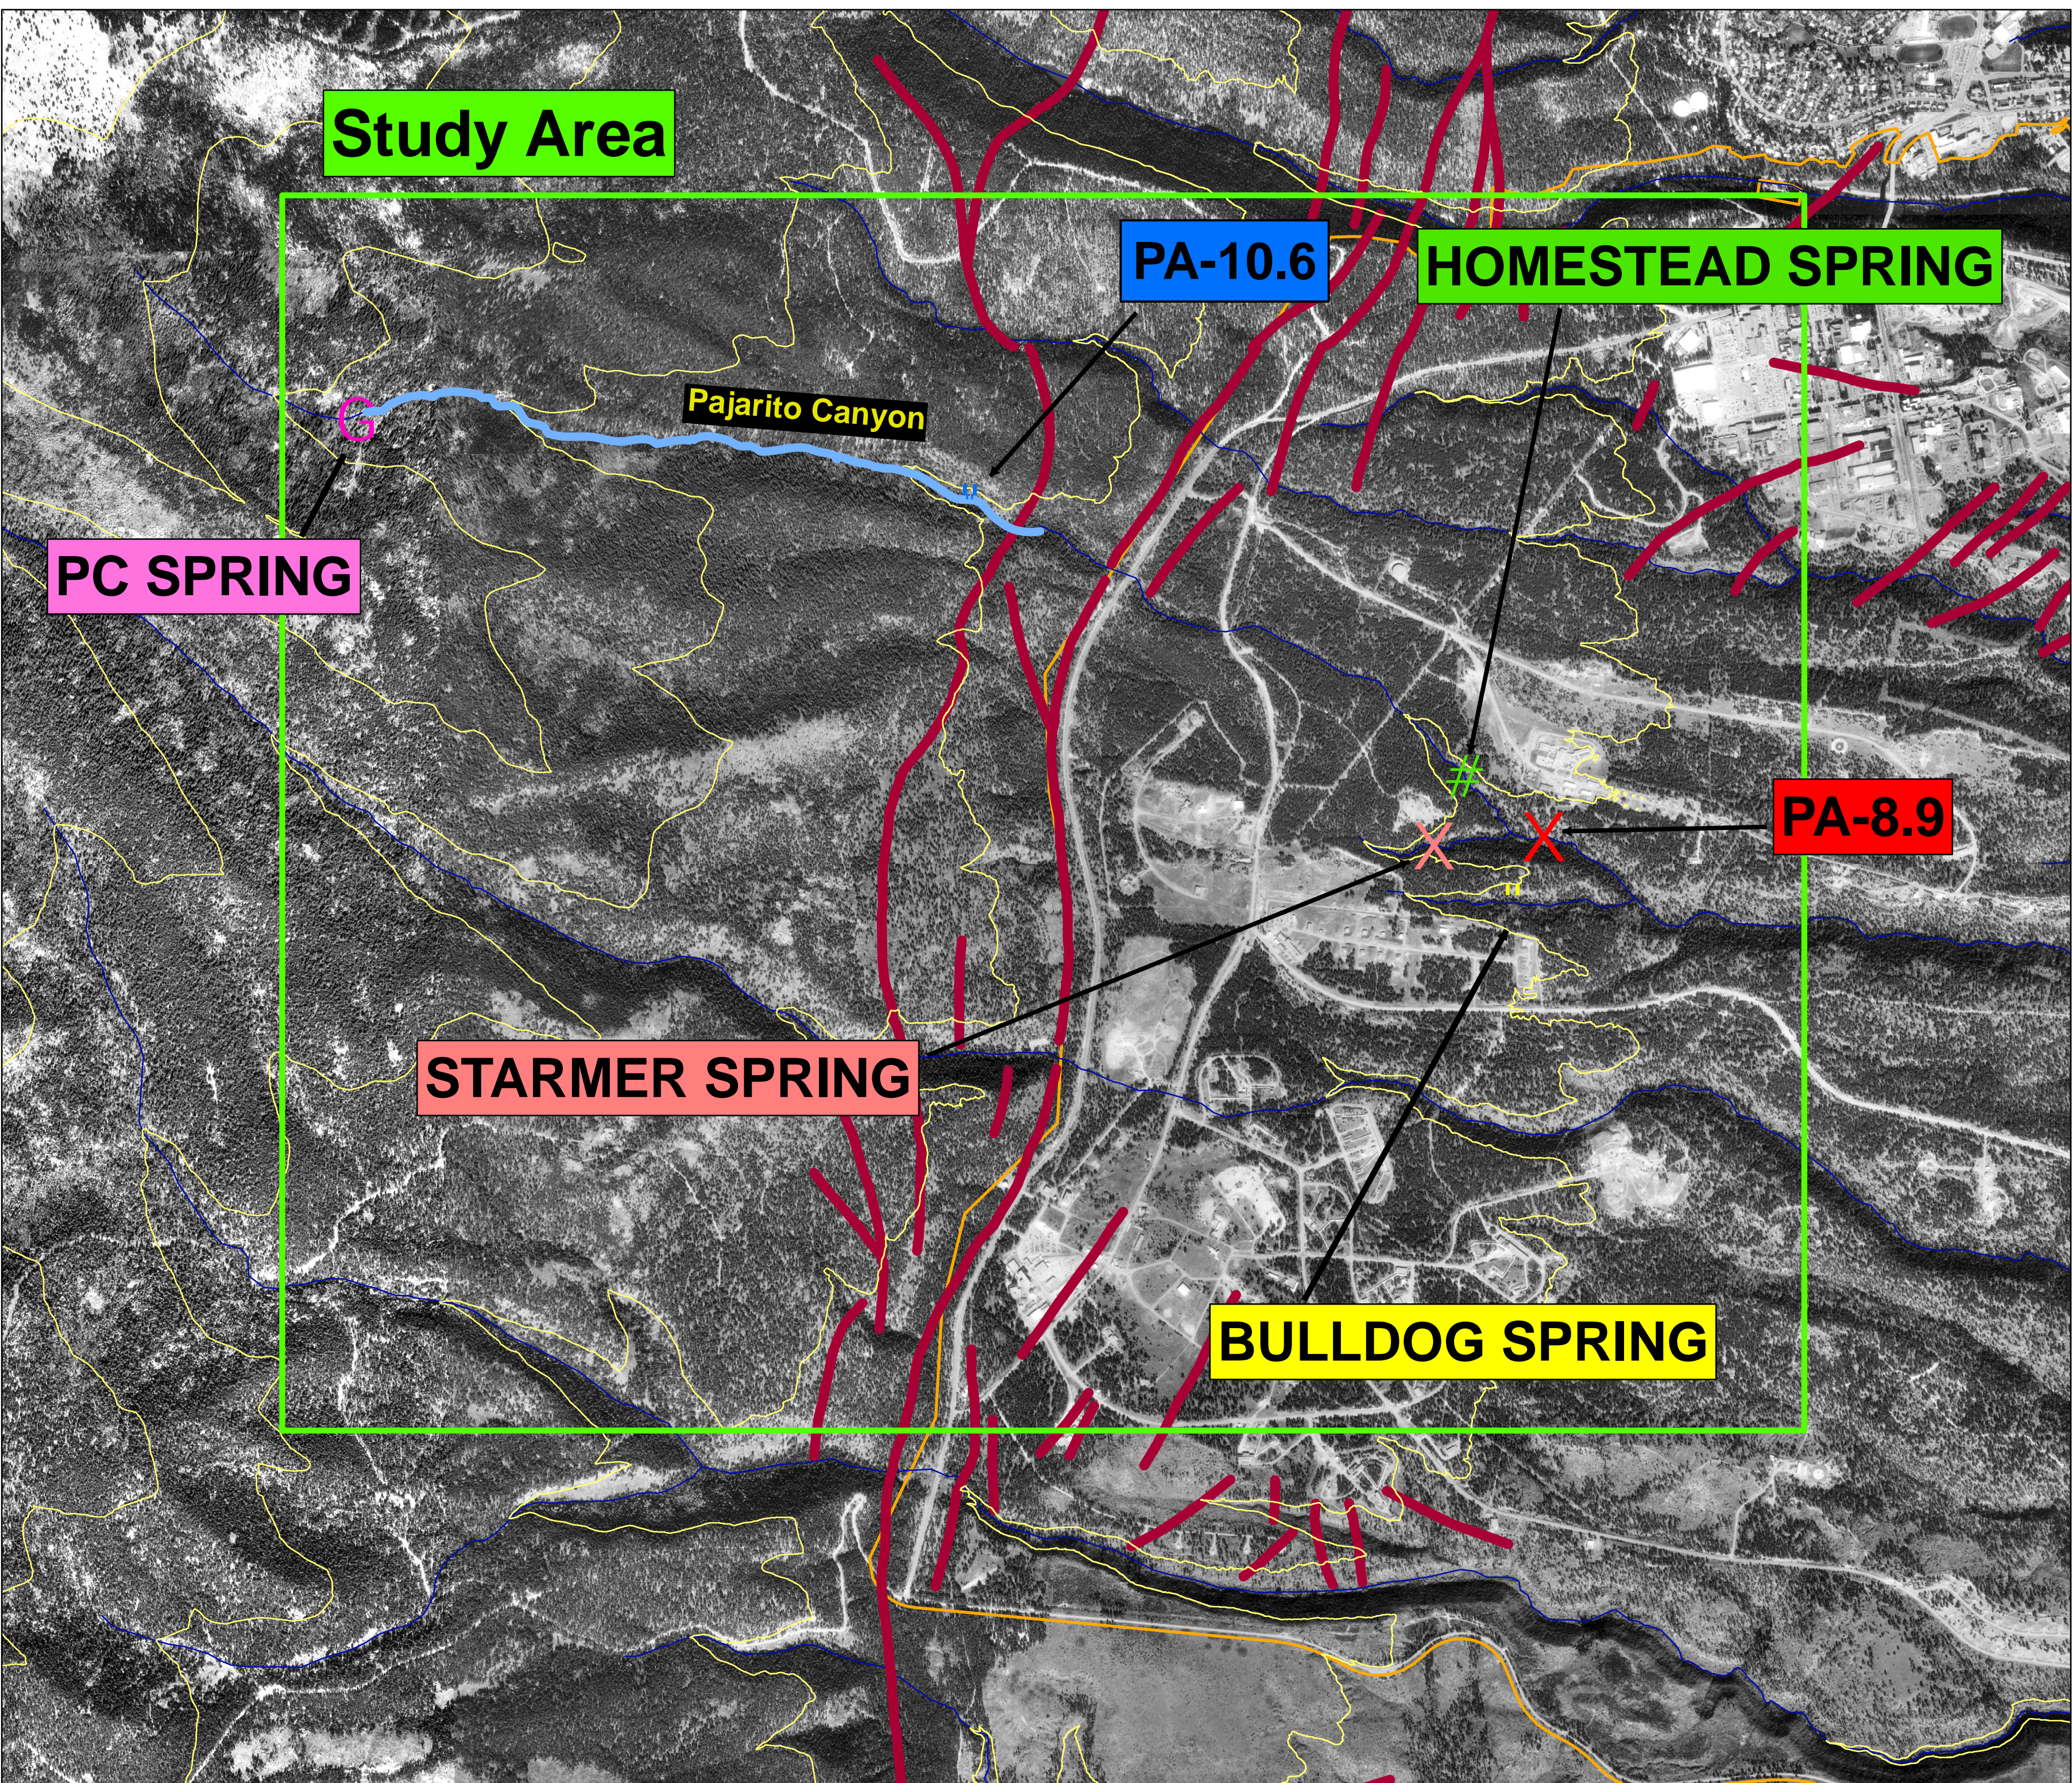
Study Area Showing PA-10.6 Surface-Water Station, Springs and Pajarito Fault Zone

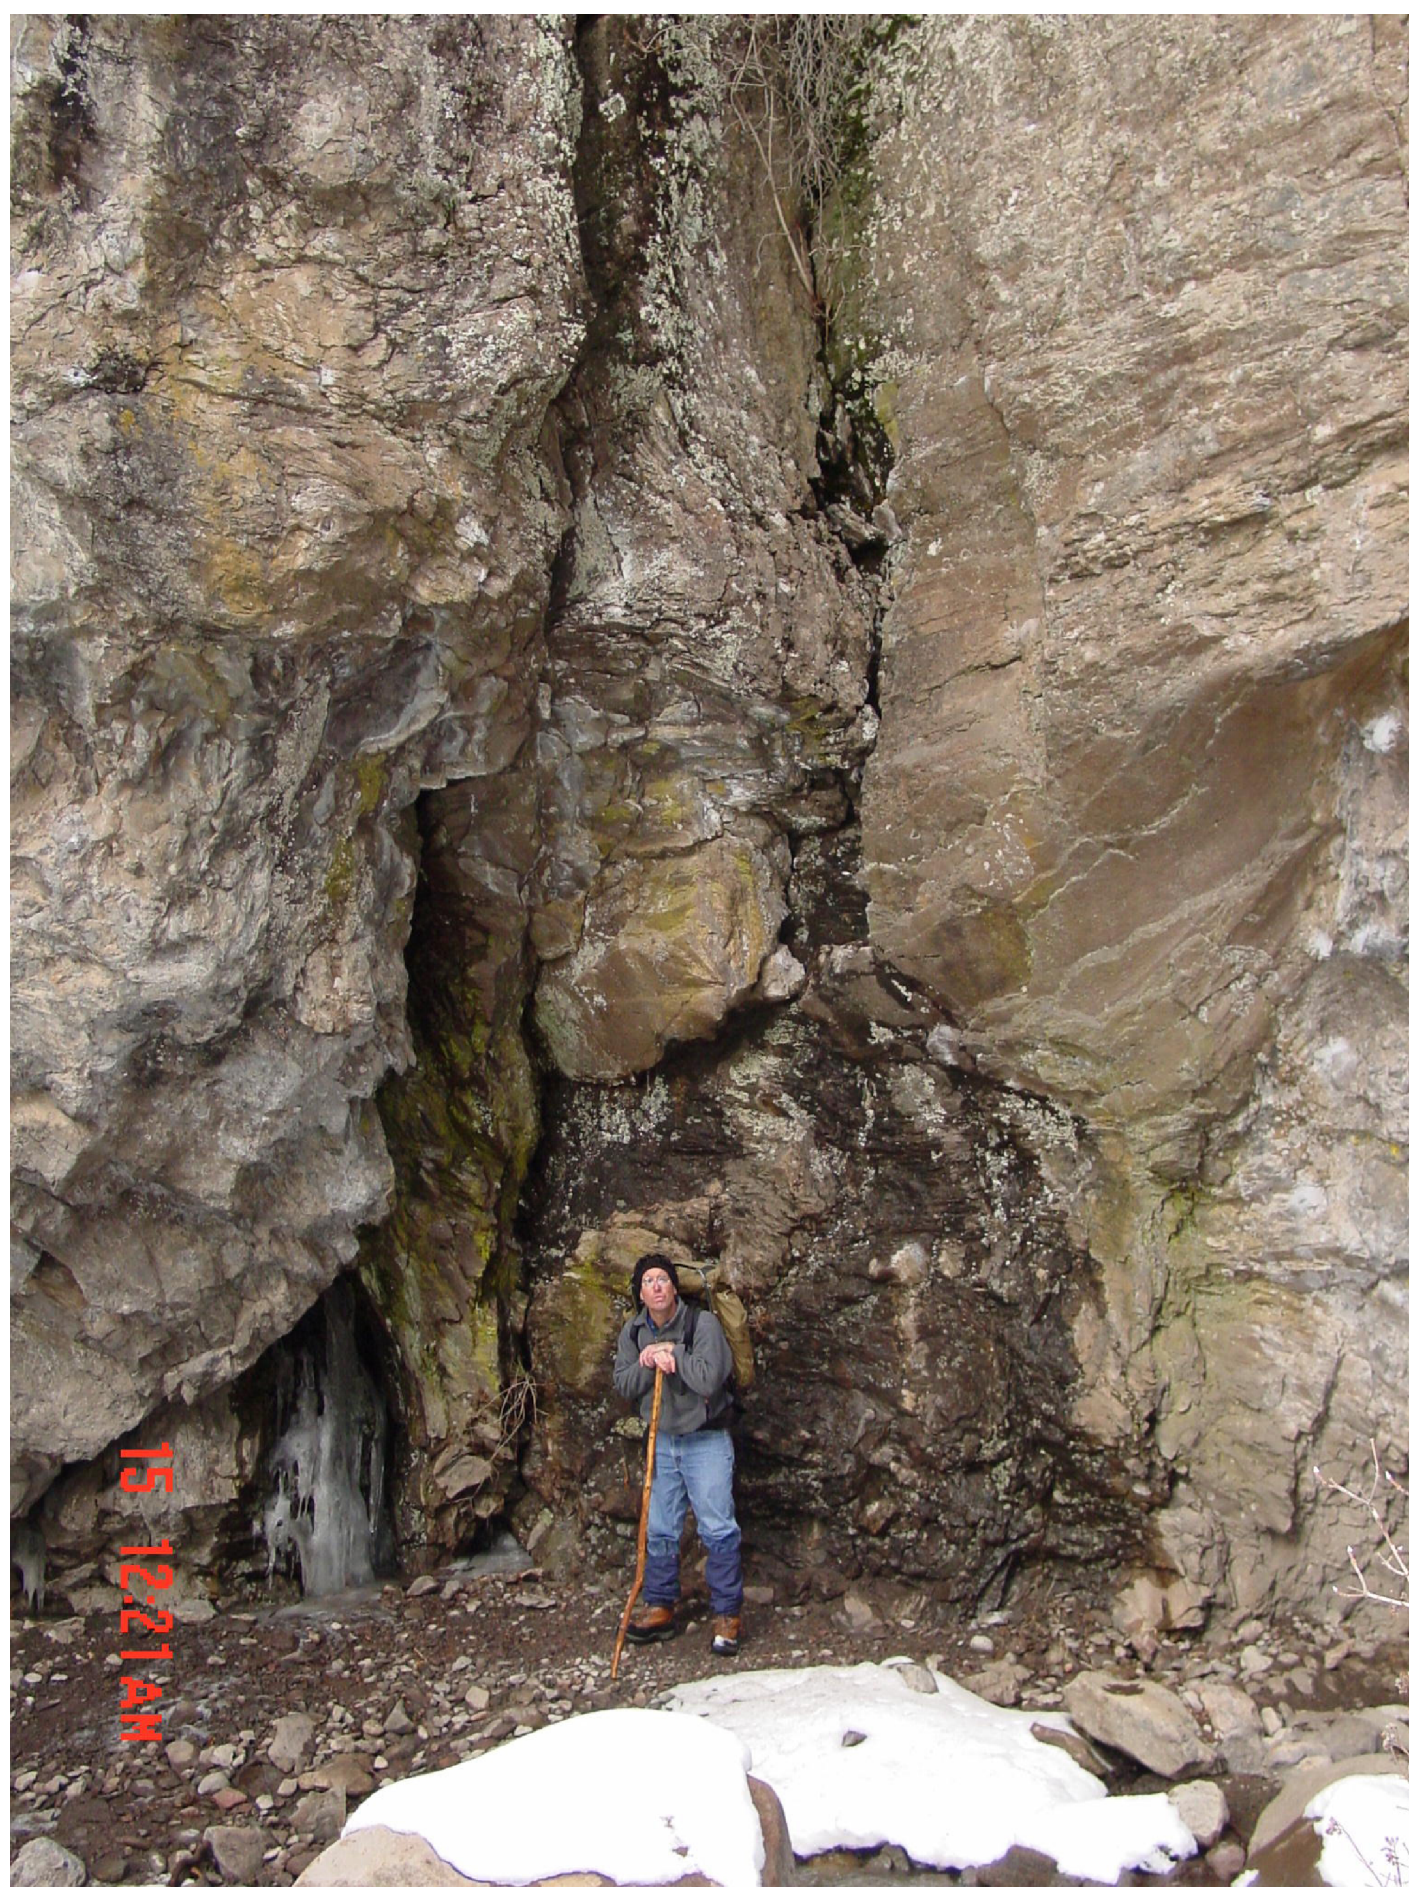
View of south wall at fault.

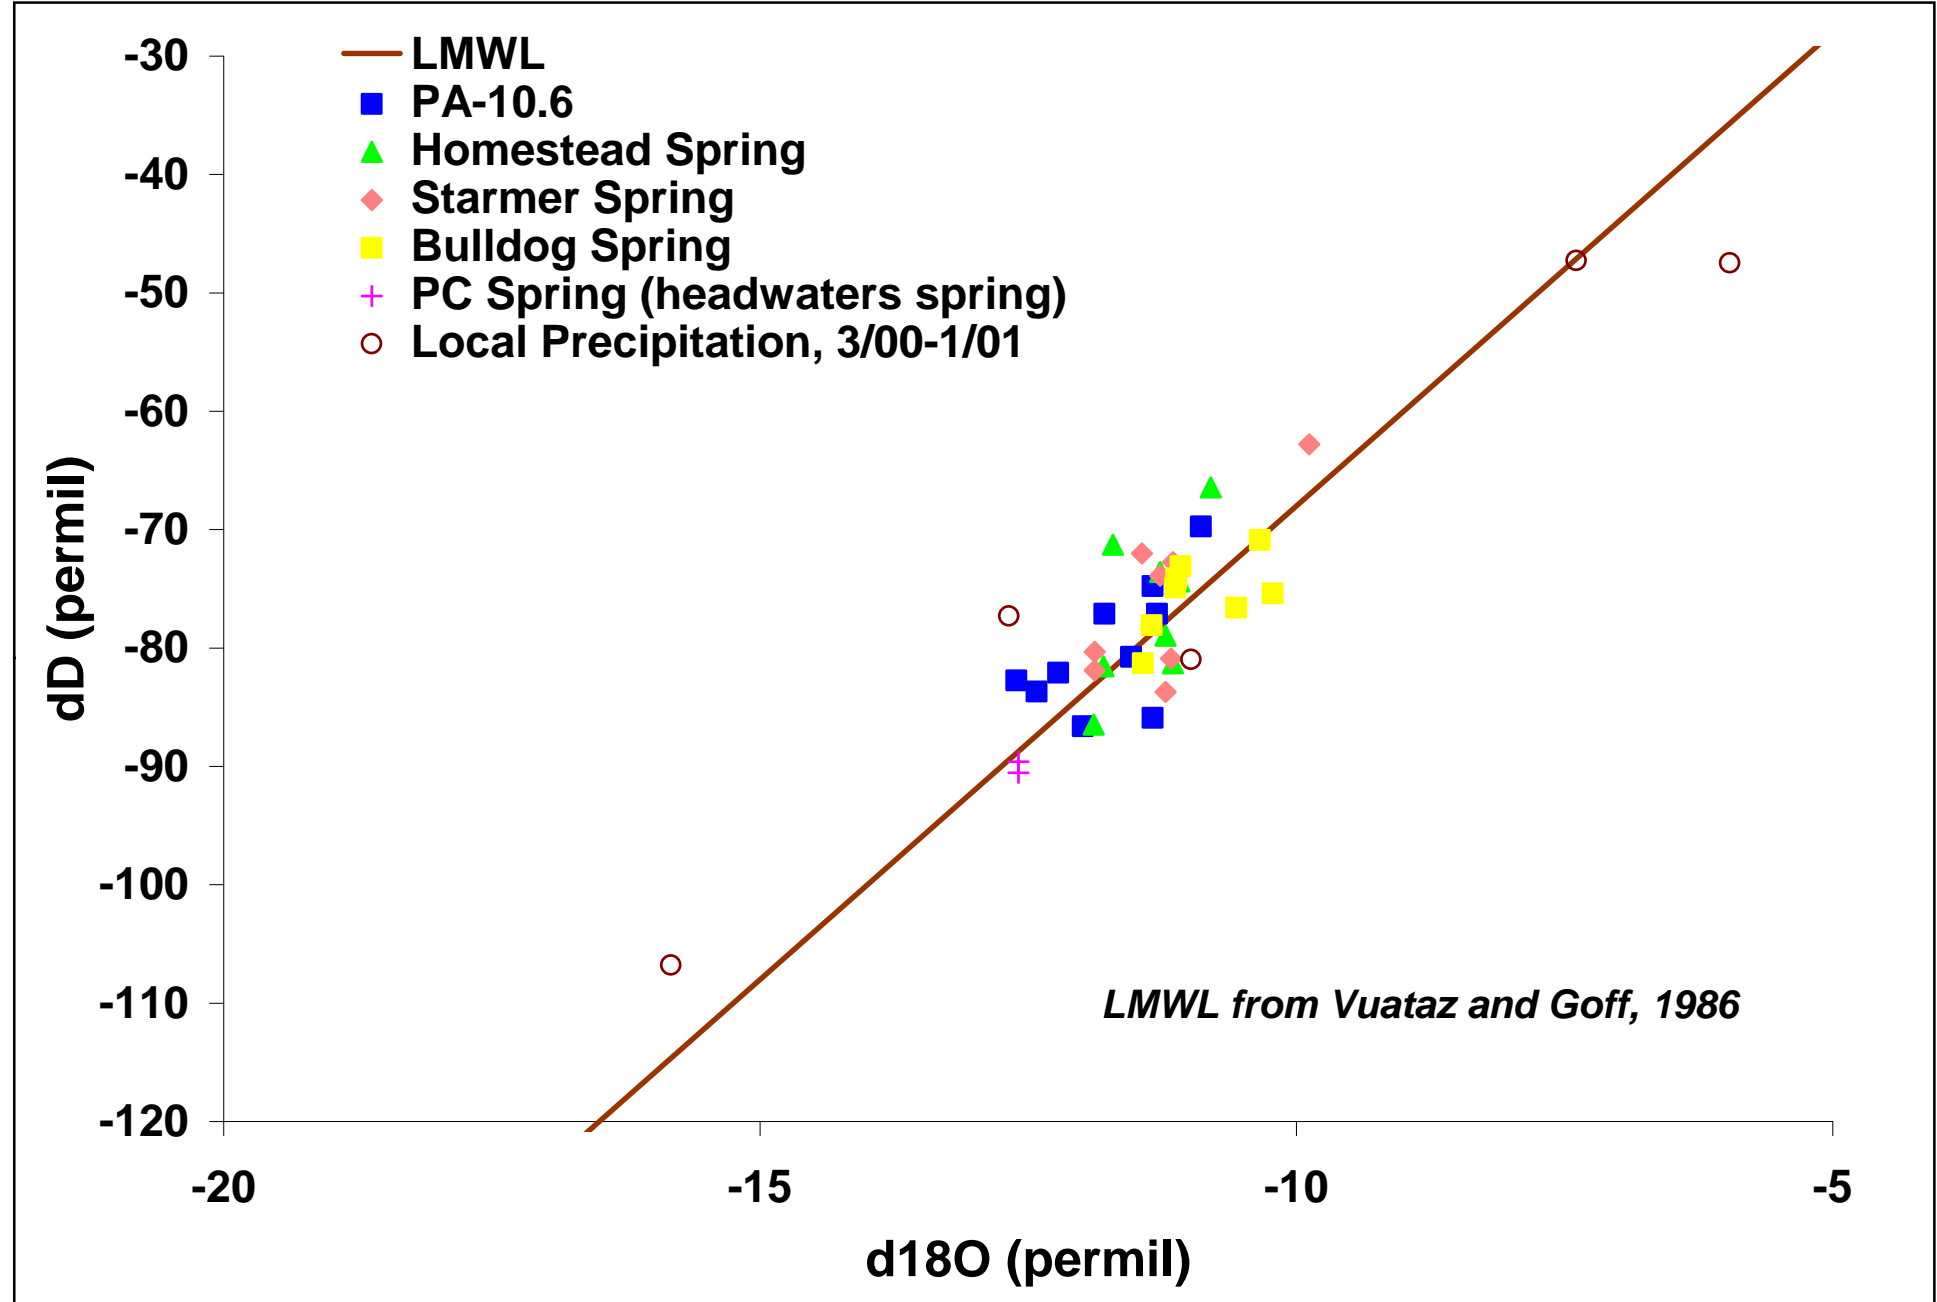
Stable-isotope comparison of local meteoric water, PA-10.6 (recharge), discharge (springs), and local precipitation.
