Homestake Mining Company Superfund Site Update

April 26, 2011

Presentation Outline

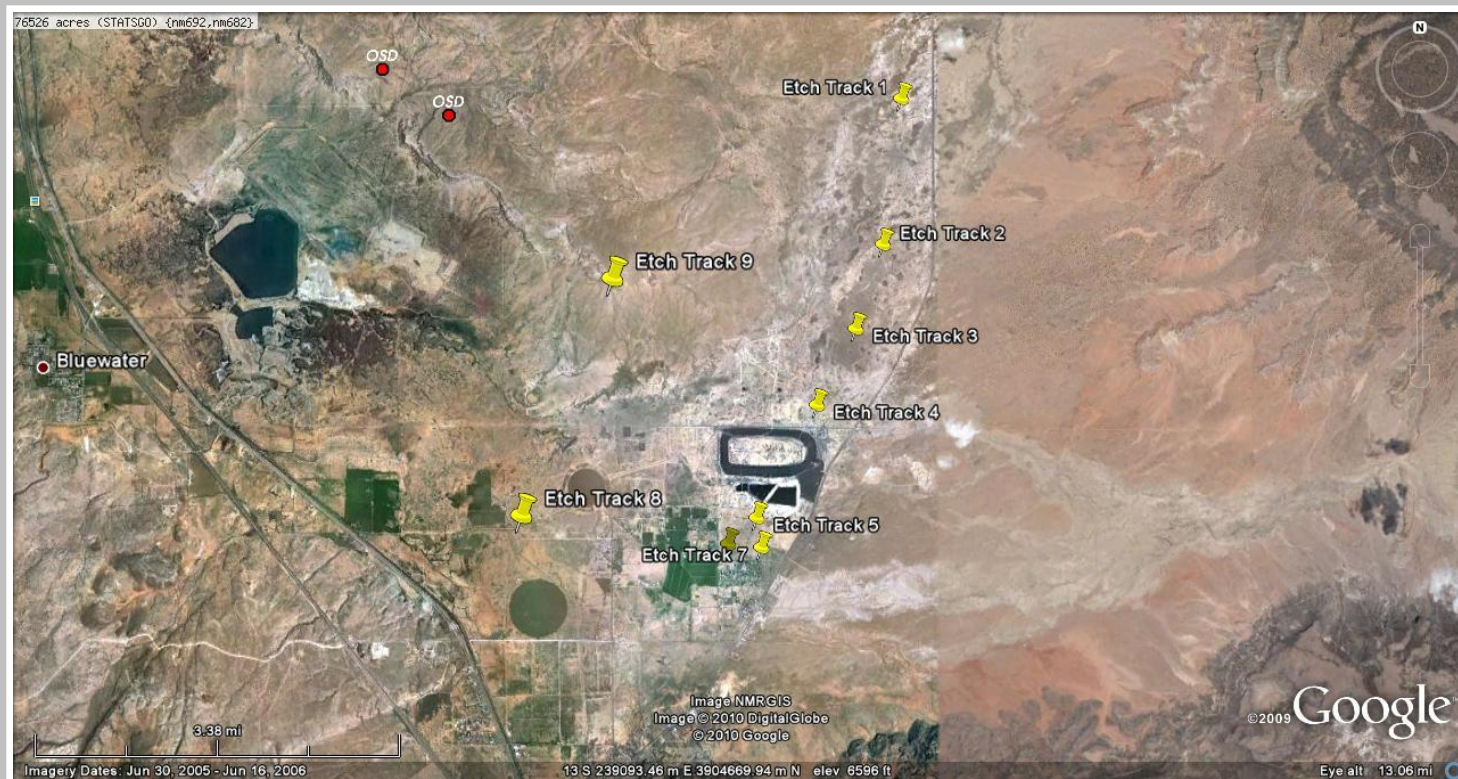
Radon Sampling on Homestake Site and Up-gradient Area

- 9 locations with track etch detectors
- Sampled every quarter for one year

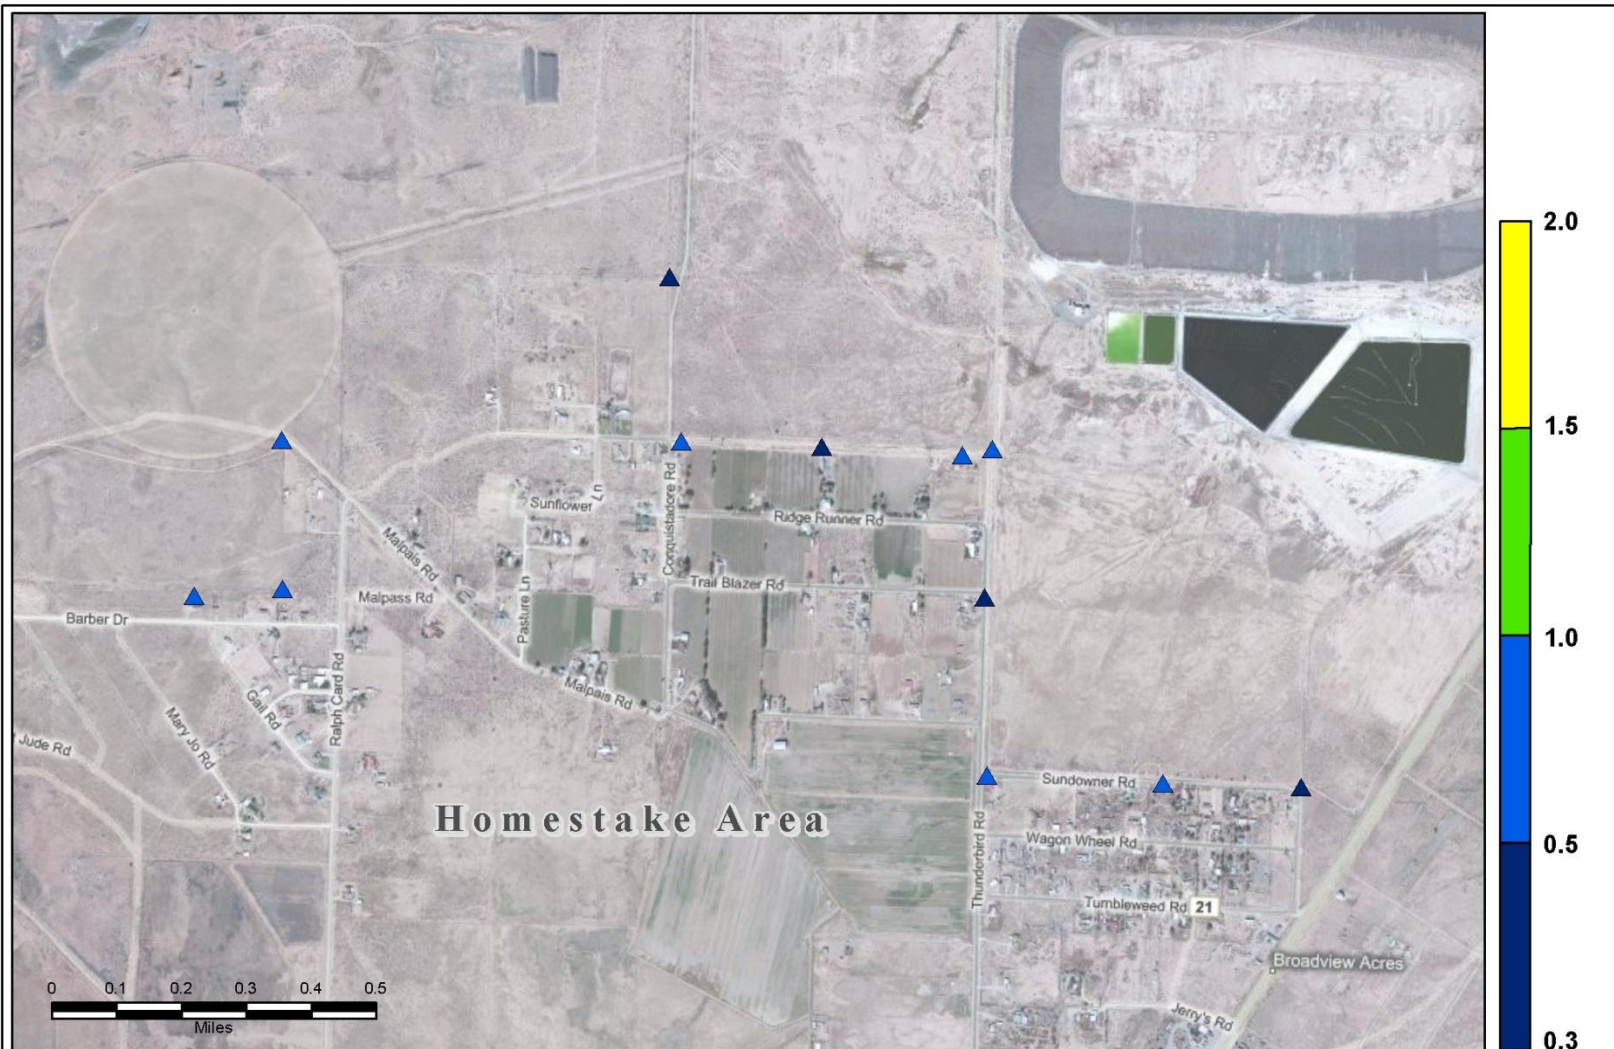
20110419ML08

Quarterly Outdoor Radon Results (pCi/L)

Based on Long-Term Samples (Lowest Result)

Fenceline Monitoring Stations

Homestake Area, New Mexico

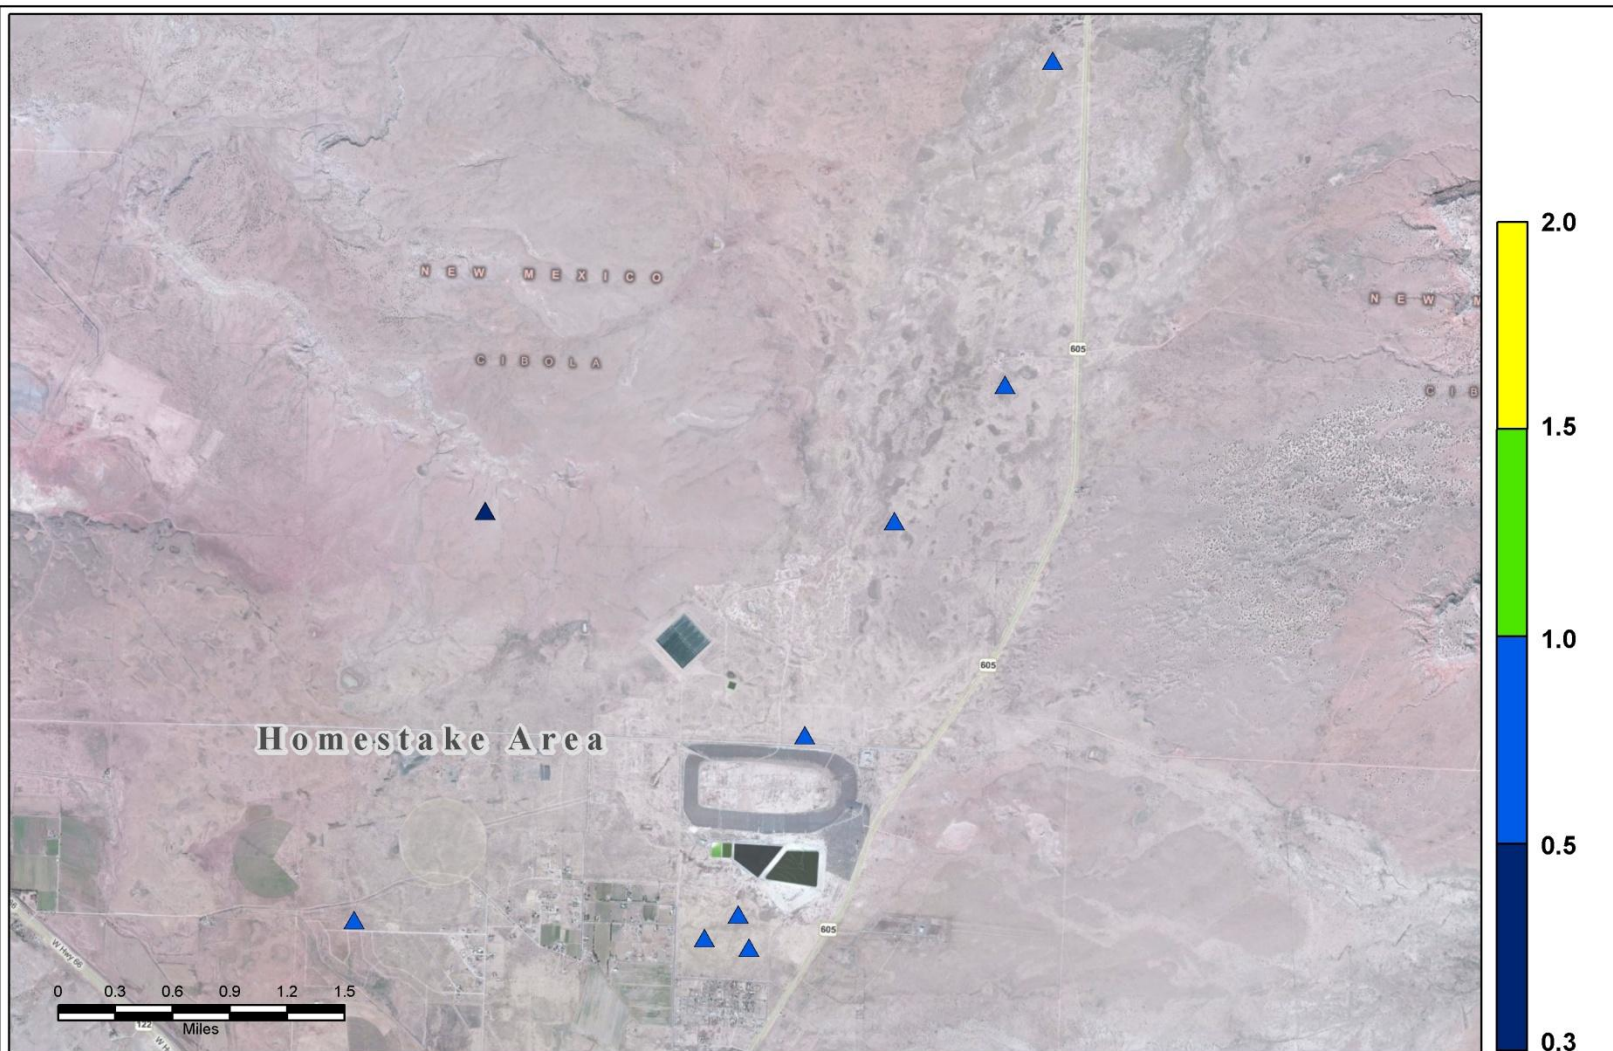
Quarterly Outdoor Radon Results (pCi/L)

Based on Long-Term Samples (Average of Results)

HMC Monitoring Stations
Homestake Area, New Mexico

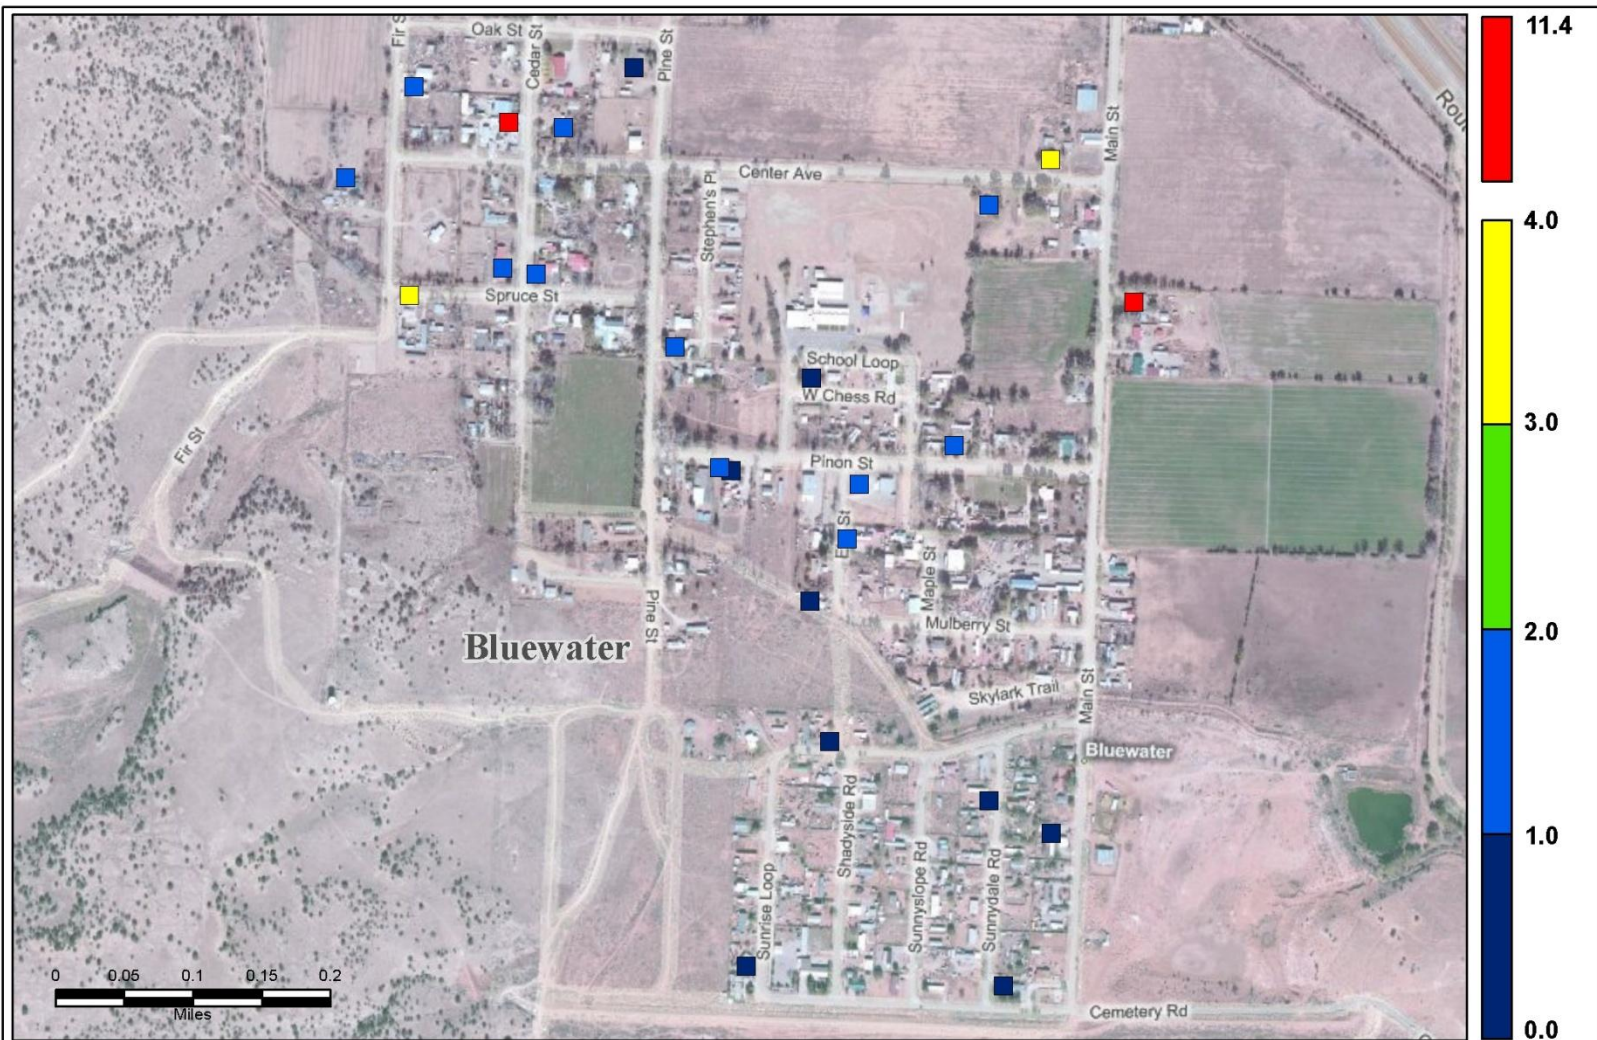
Quarterly Indoor Radon Results (pCi/L)

Based on Long-Term Samples

Bluewater, New Mexico

- Outdoor radon levels lower than Milan Area
- Indoor radon levels in approximately 6% of the homes exceed EPA recommended guidance of 4 pCi/l

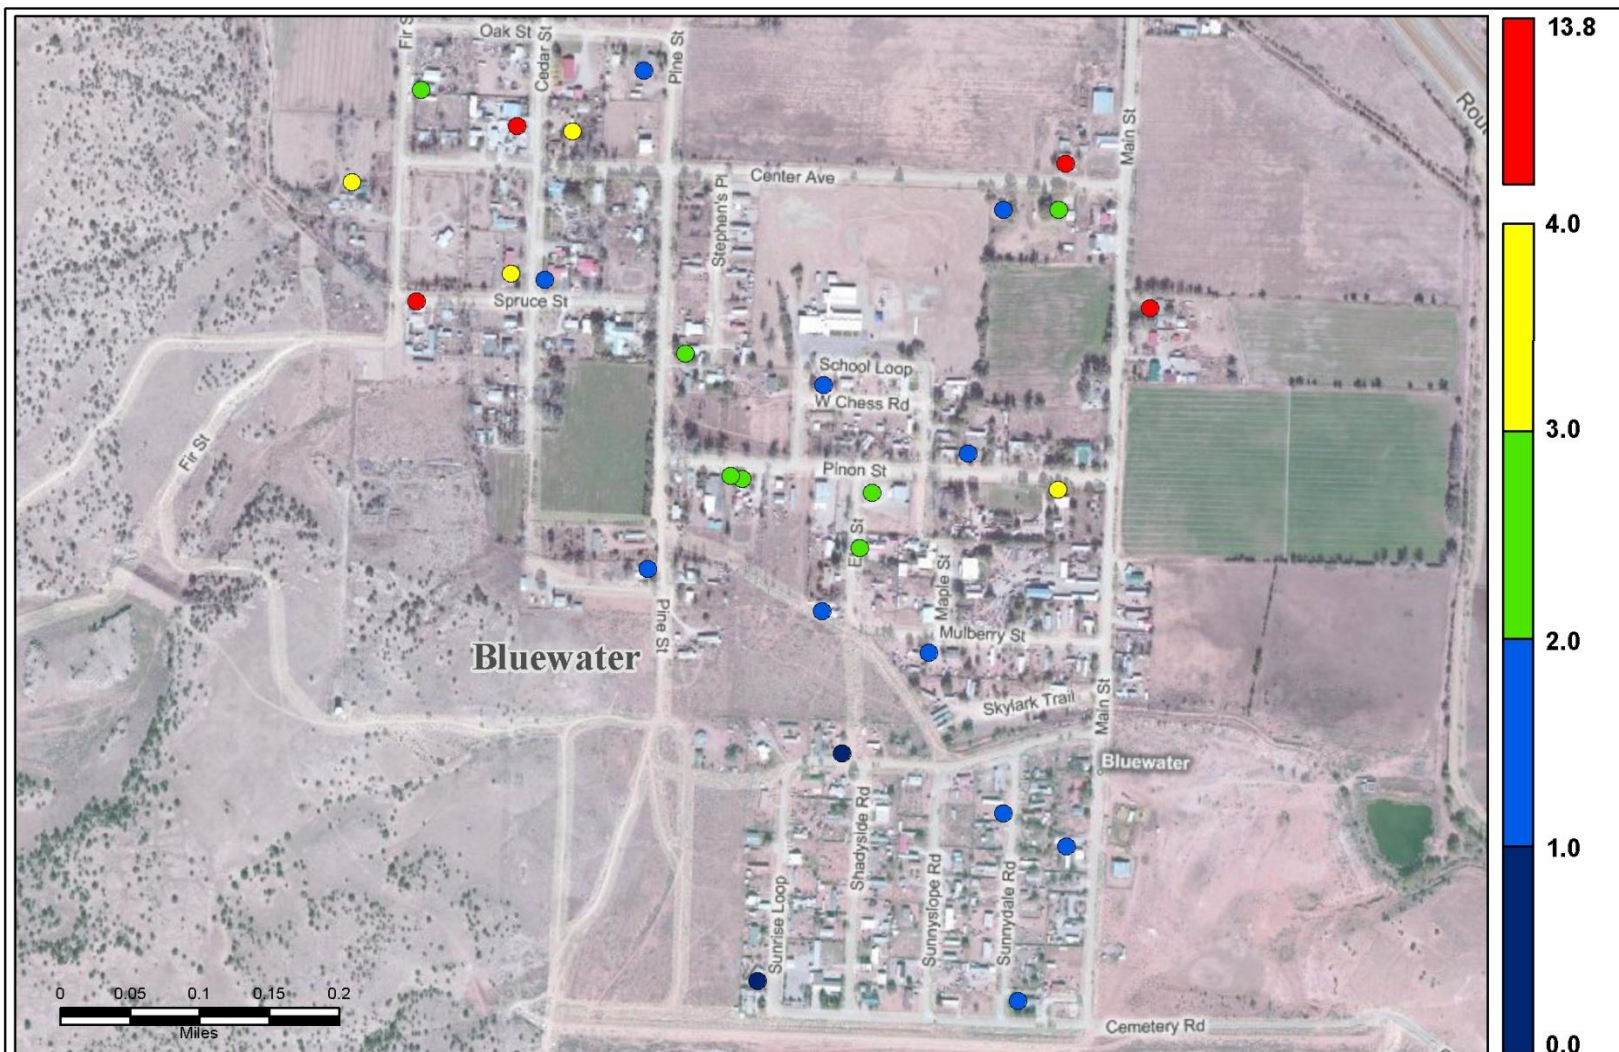
Short-Term Indoor Radon Results (pCi/L)

Based on Short-Term Samples (6 days)

Bluewater, New Mexico

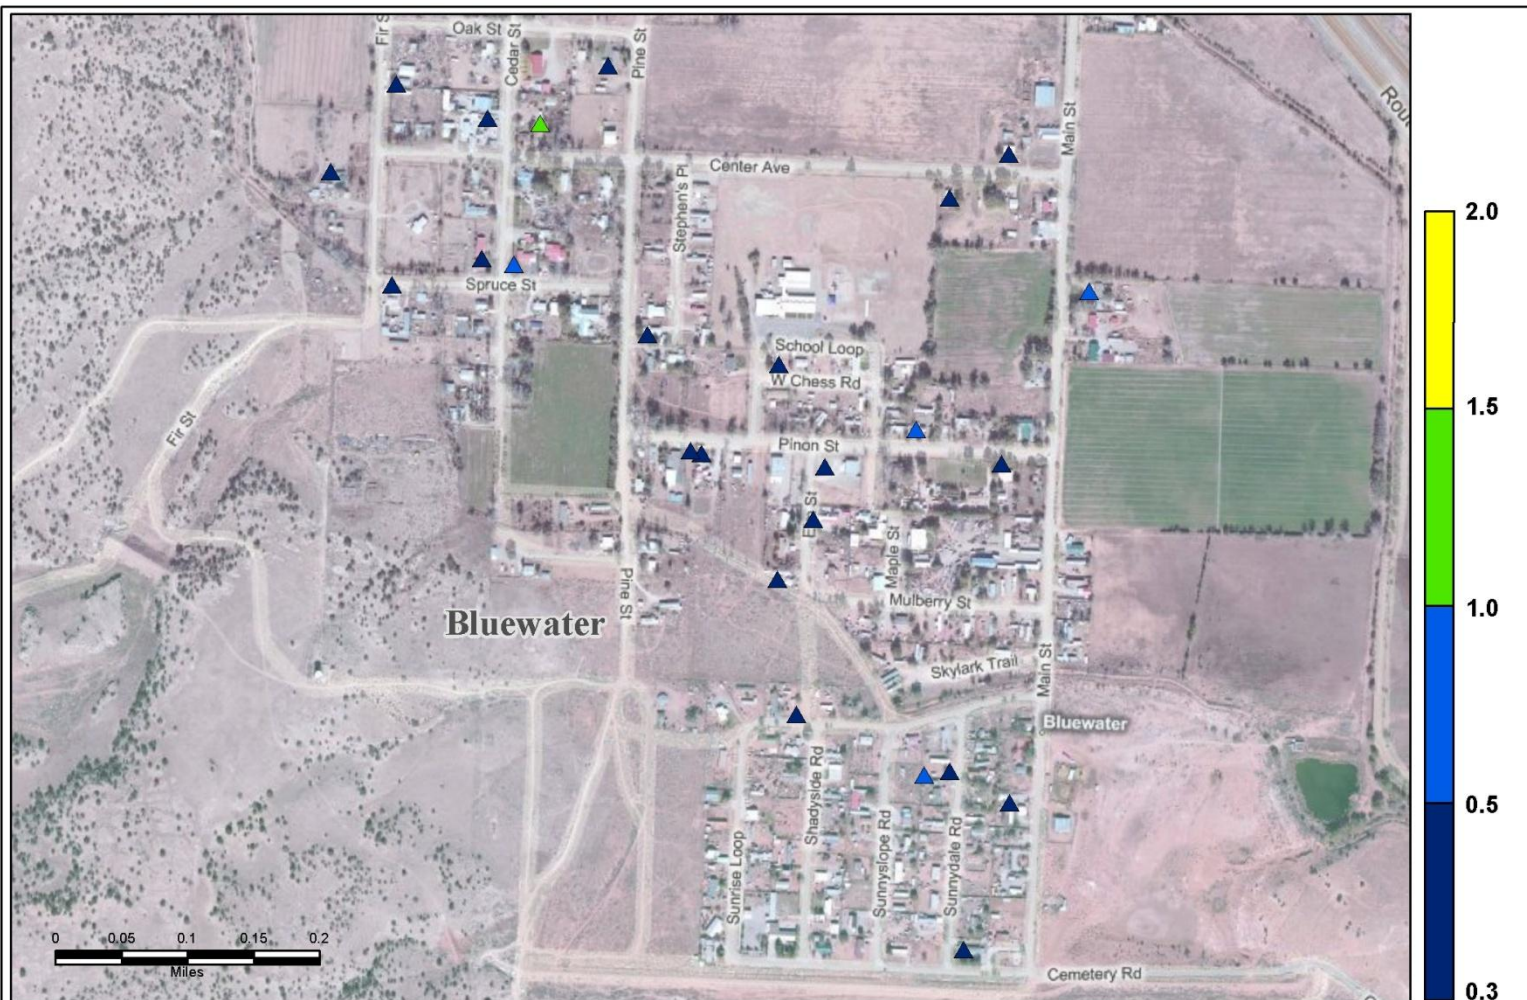
20110415ML04

Quarterly Outdoor Radon Results (pCi/L)

Based on Long-Term Samples

Bluewater, New Mexico

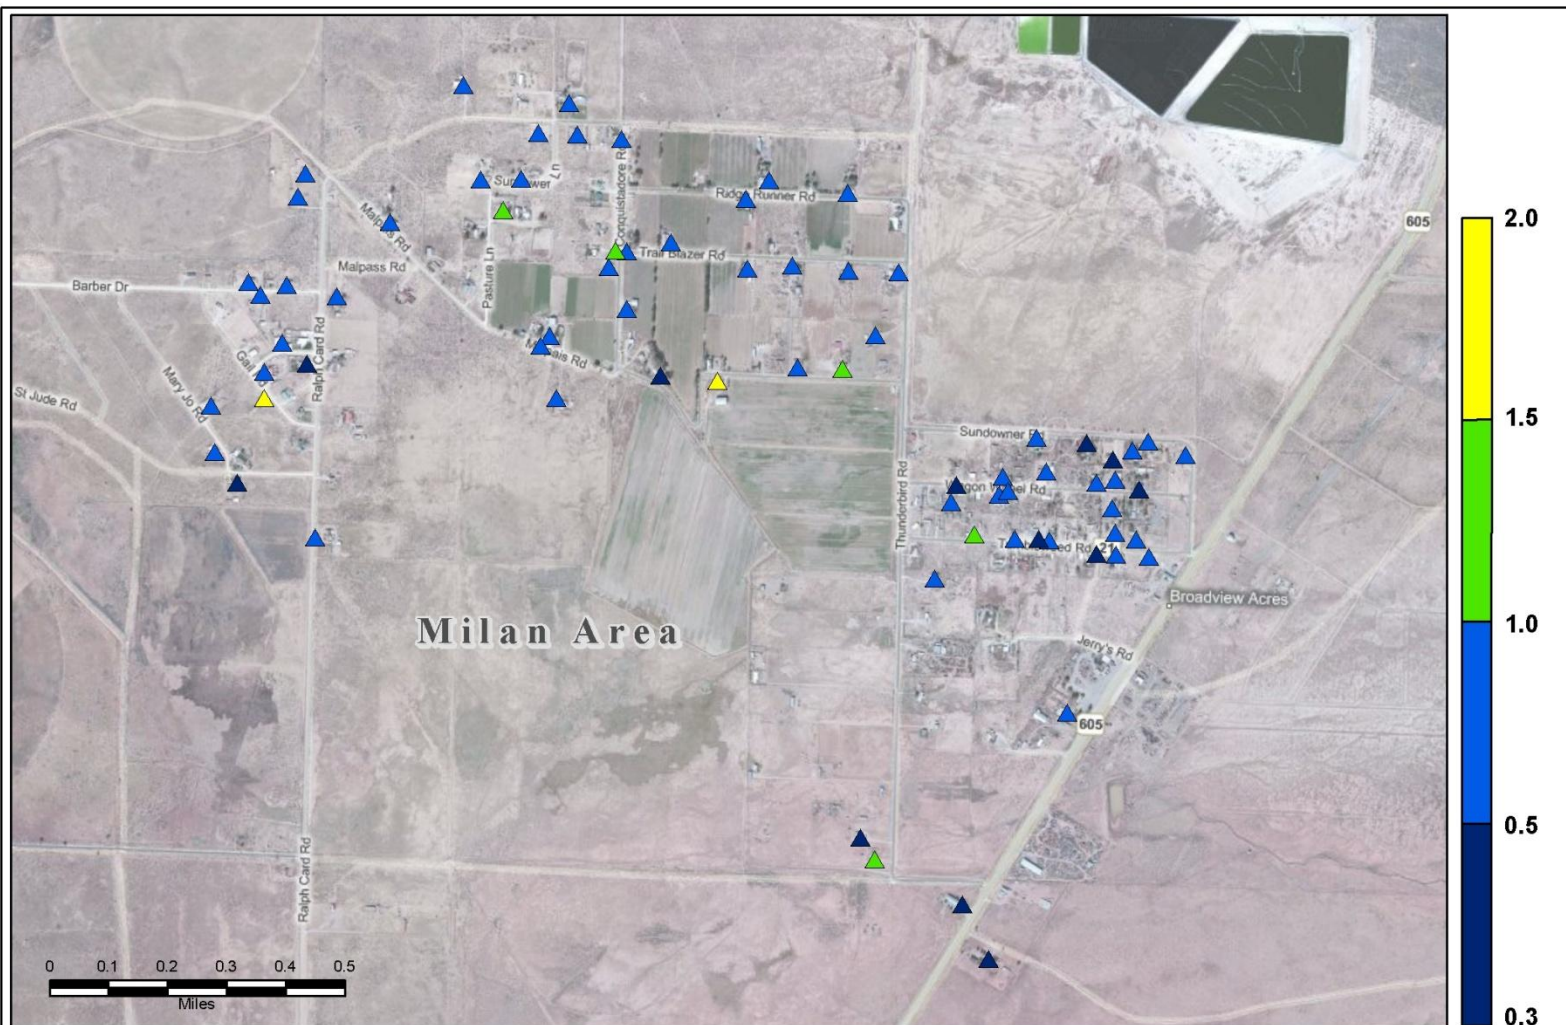
20110419ML05

Quarterly Outdoor Radon Results (pCi/L)

Based on Long-Term Samples

Milan Area, New Mexico

- Outdoor radon levels are less than 1 pCi/l
- Indoor radon levels in approximately 10% of the homes exceed the EPA recommended guidance of 4 pCi/l
- Source is still unknown

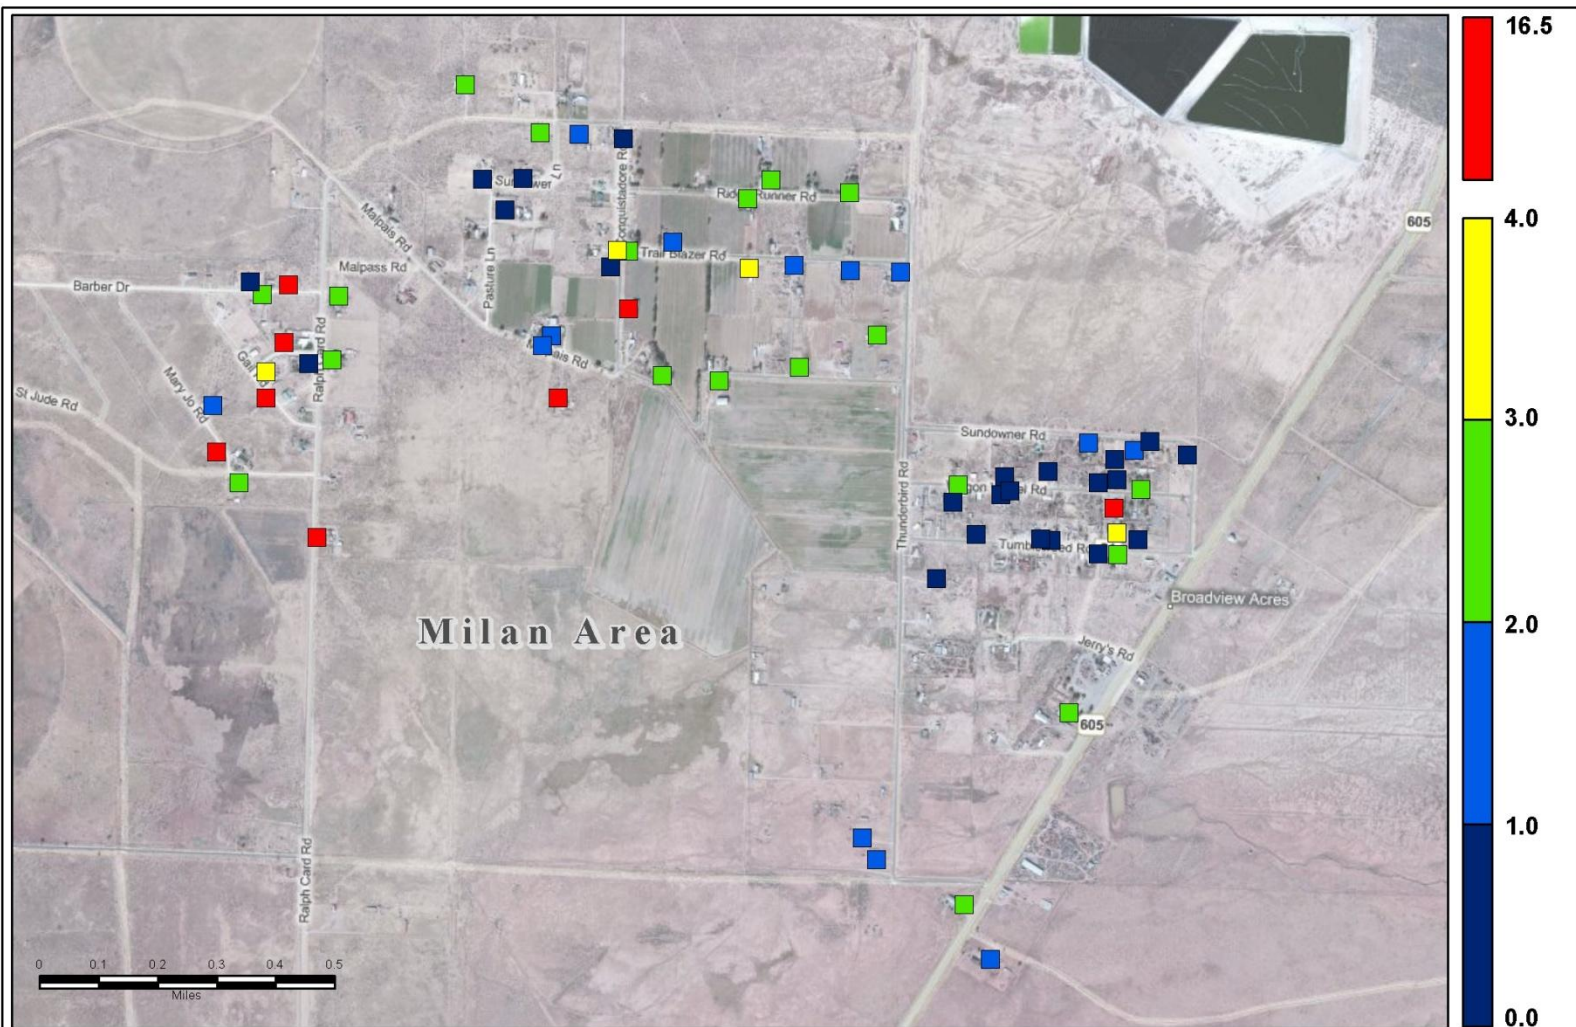
Quarterly Indoor Radon Results (pCi/L)

Based on Long-Term Samples
Milan Area, New Mexico

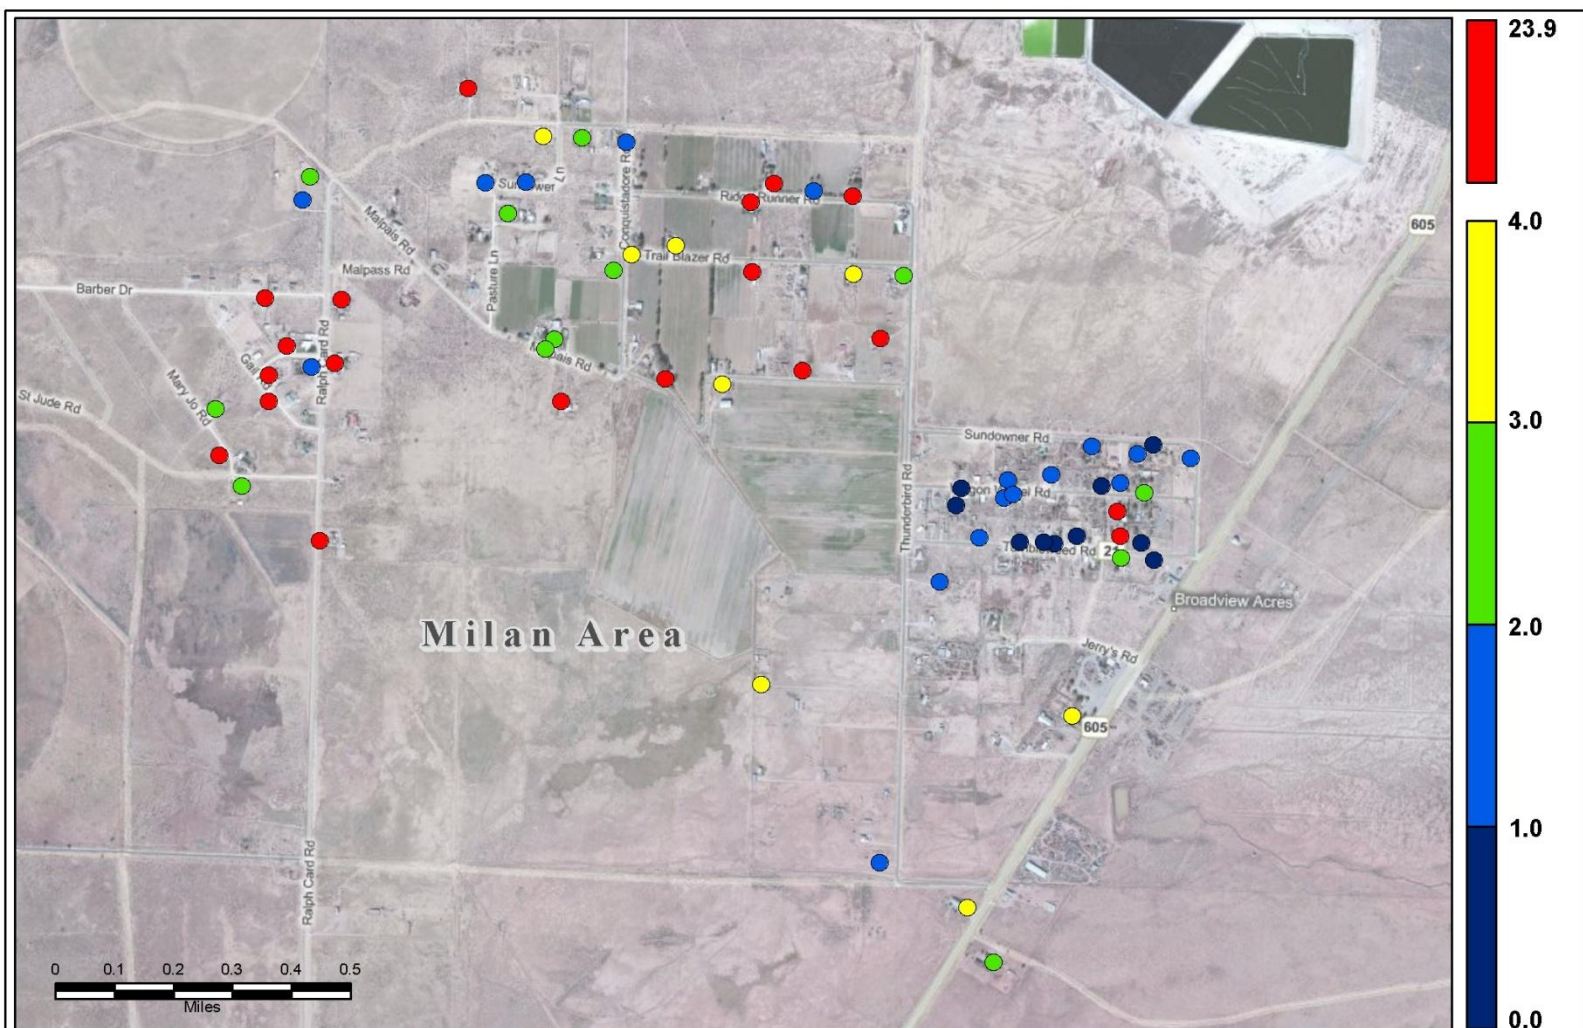
20110419ML06

Short-Term Indoor Radon Results (pCi/L)

Based on Short-Term Samples (6 days)

Milan Area, New Mexico
