NOTICE OF NON-COMPLIANCE

RE: **Copper Penny Debris Pile ACM Screening**
Highway 64
Farmington, San Juan County, New Mexico
iiná bá Project No.: 21-003-03

ATTACHMENTS
COPPER PENNY DEBRIS PILE ACM SCREENING
HECTOR RANGEL
FARMINGTON, SAN JUAN COUNTY, NEW MEXICO

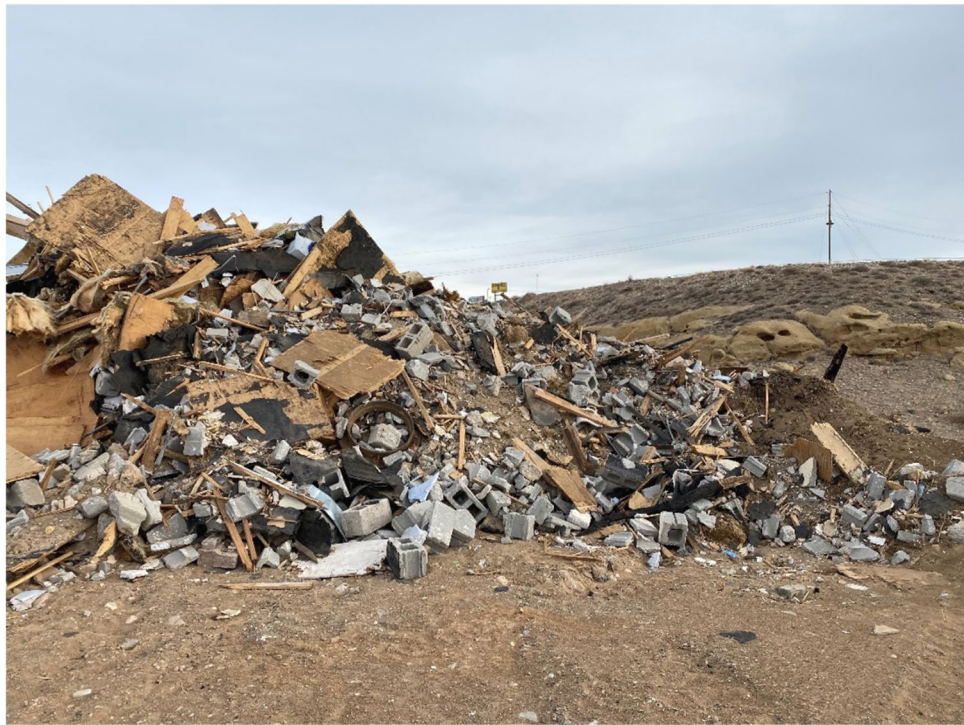
Photograph 1: Representative view of debris pile looking east.

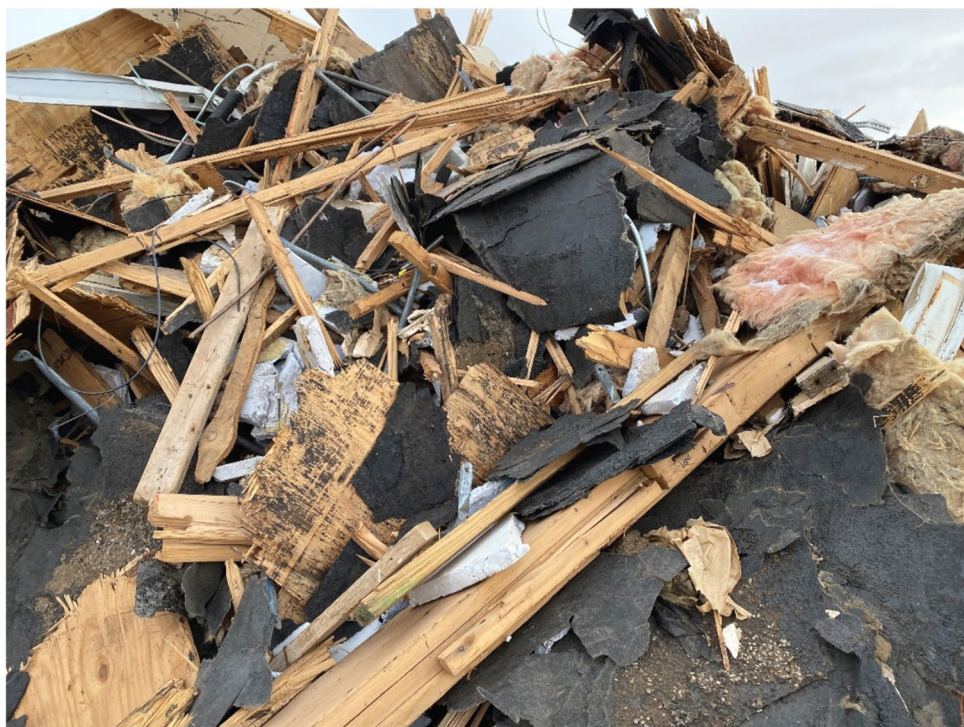
The resulting analysis of these bulk samples indicate that none of the submitted suspect building materials contain detectable amounts of asbestos fibers (non-detect). Therefore, it can be concluded that based on this sampling event, regulated asbestos-containing building materials (ACBM) are not indicated to be present in the subject debris pile. A copy of the Report of Laboratory Analysis and COC are attached.

Photograph 2: Closer view of debris pile showing scattered suspect roofing and wall materials.

The SWB hereby requests that you provide the name of the solid waste disposal facility to which the C&D debris will be taken, the identity of the person or company which will transport the C&D debris, and copies of the disposal tickets verifying the type and volume of waste. Please contact me at (505) 795-4307 or jaimerodriguez@state.nm.us within 10 calendar days of receipt of this correspondence to verify corrective action and to answer any questions regarding this notice.
